Taroborah Coal Project

Taroborah Coal Mine - Preliminary Non-intrusive Contaminated Land Assessment Report

Shenhua International Group Pty Ltd

December 2013

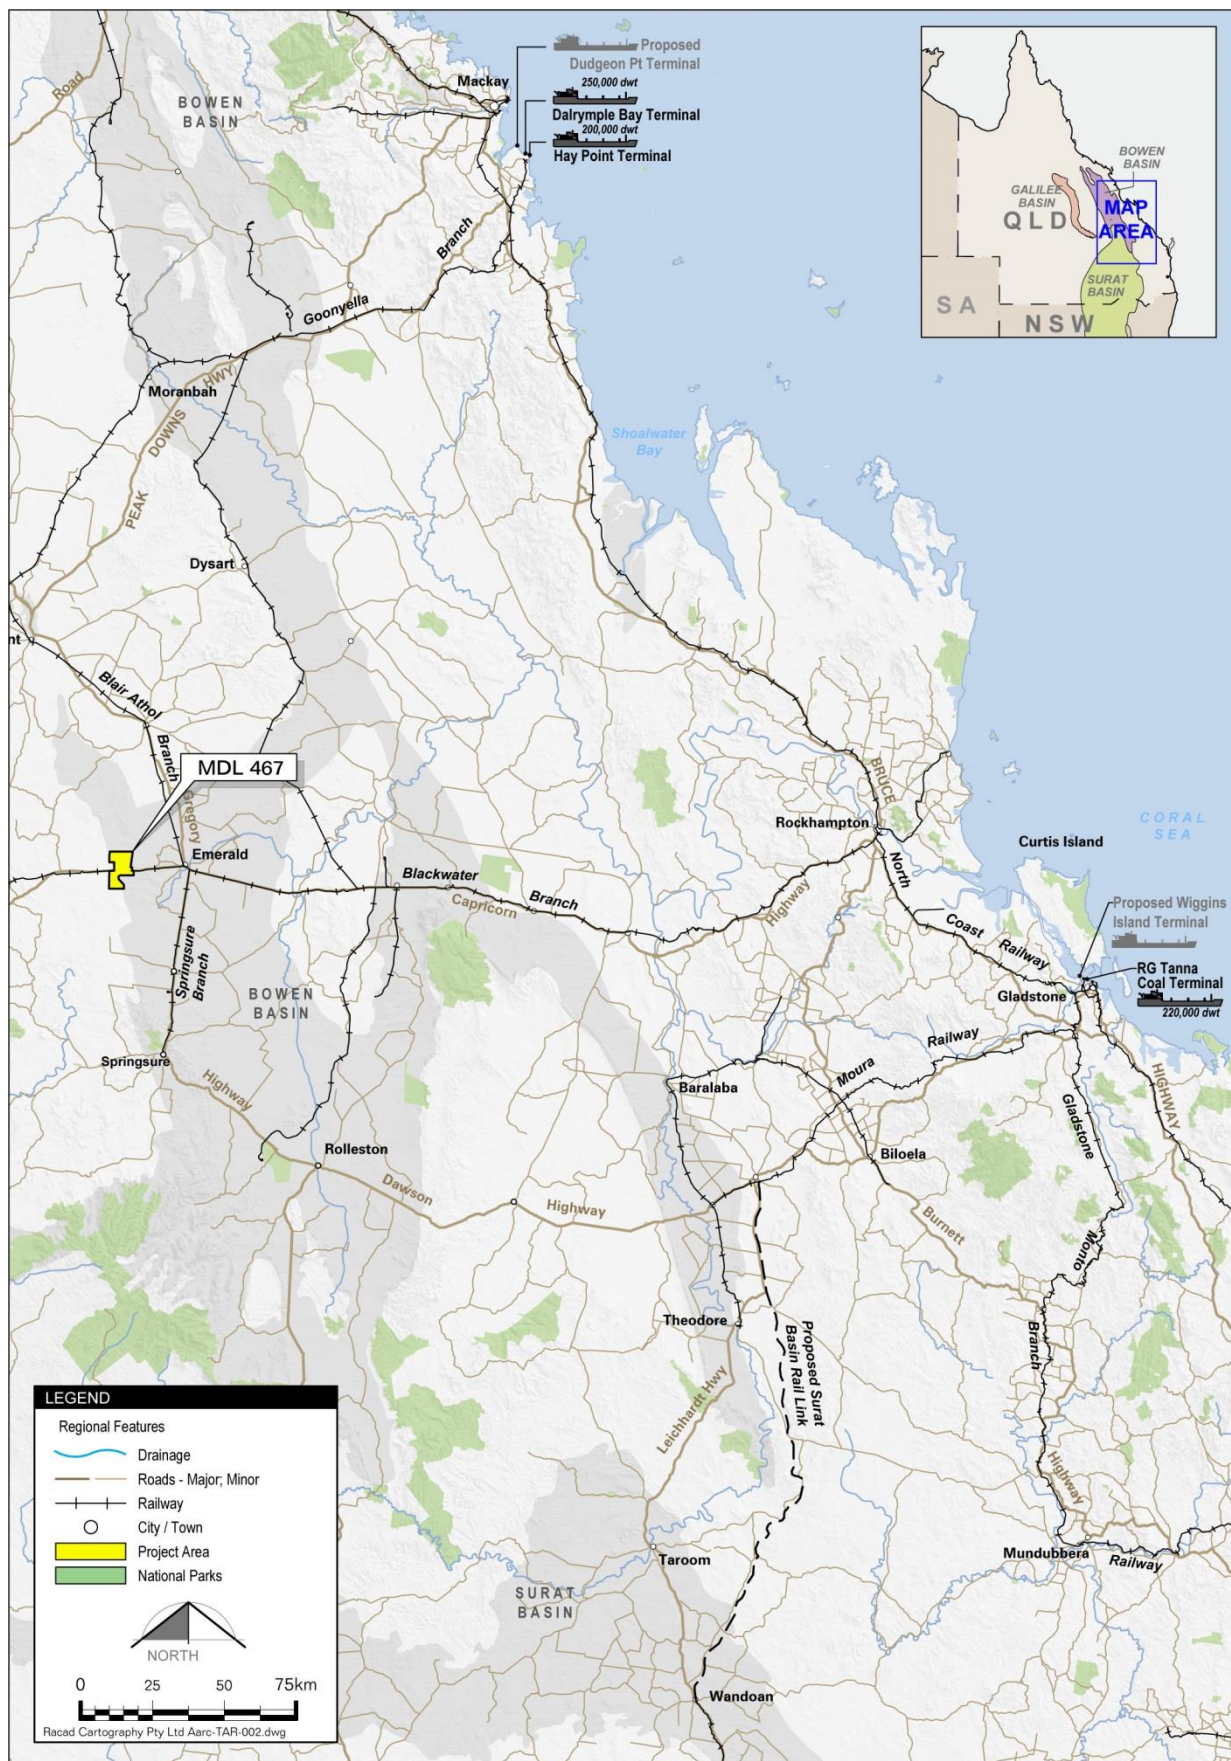
Figure 1 Regional Site Location

Figure 1 is a map of the study area, showing the location of the MDL (Mudstone Development Line) in the central part of the map. The map is overlaid with a grid of UTM coordinates (Easting and Northing). A red outline indicates the MDL. A north arrow and a scale bar (0 to 4 kilometers) are also present.

The Taroborah Project site is located 22 km due west of the city of Emerald. The site area extends either side of the Capricorn Highway / Central West railway line corridor, which runs between Emerald and Longreach (refer to Figure 1 for the regional location of the Project).

For the purposes of this preliminary site investigation, the Project site is delineated by MDL467, which covers an area of approximately 7,966 hectares (Ha) and exhibits a site centroid of 596500 m East and 7396000 m South (refer to Figure 1 and Figure 2 for site location details).

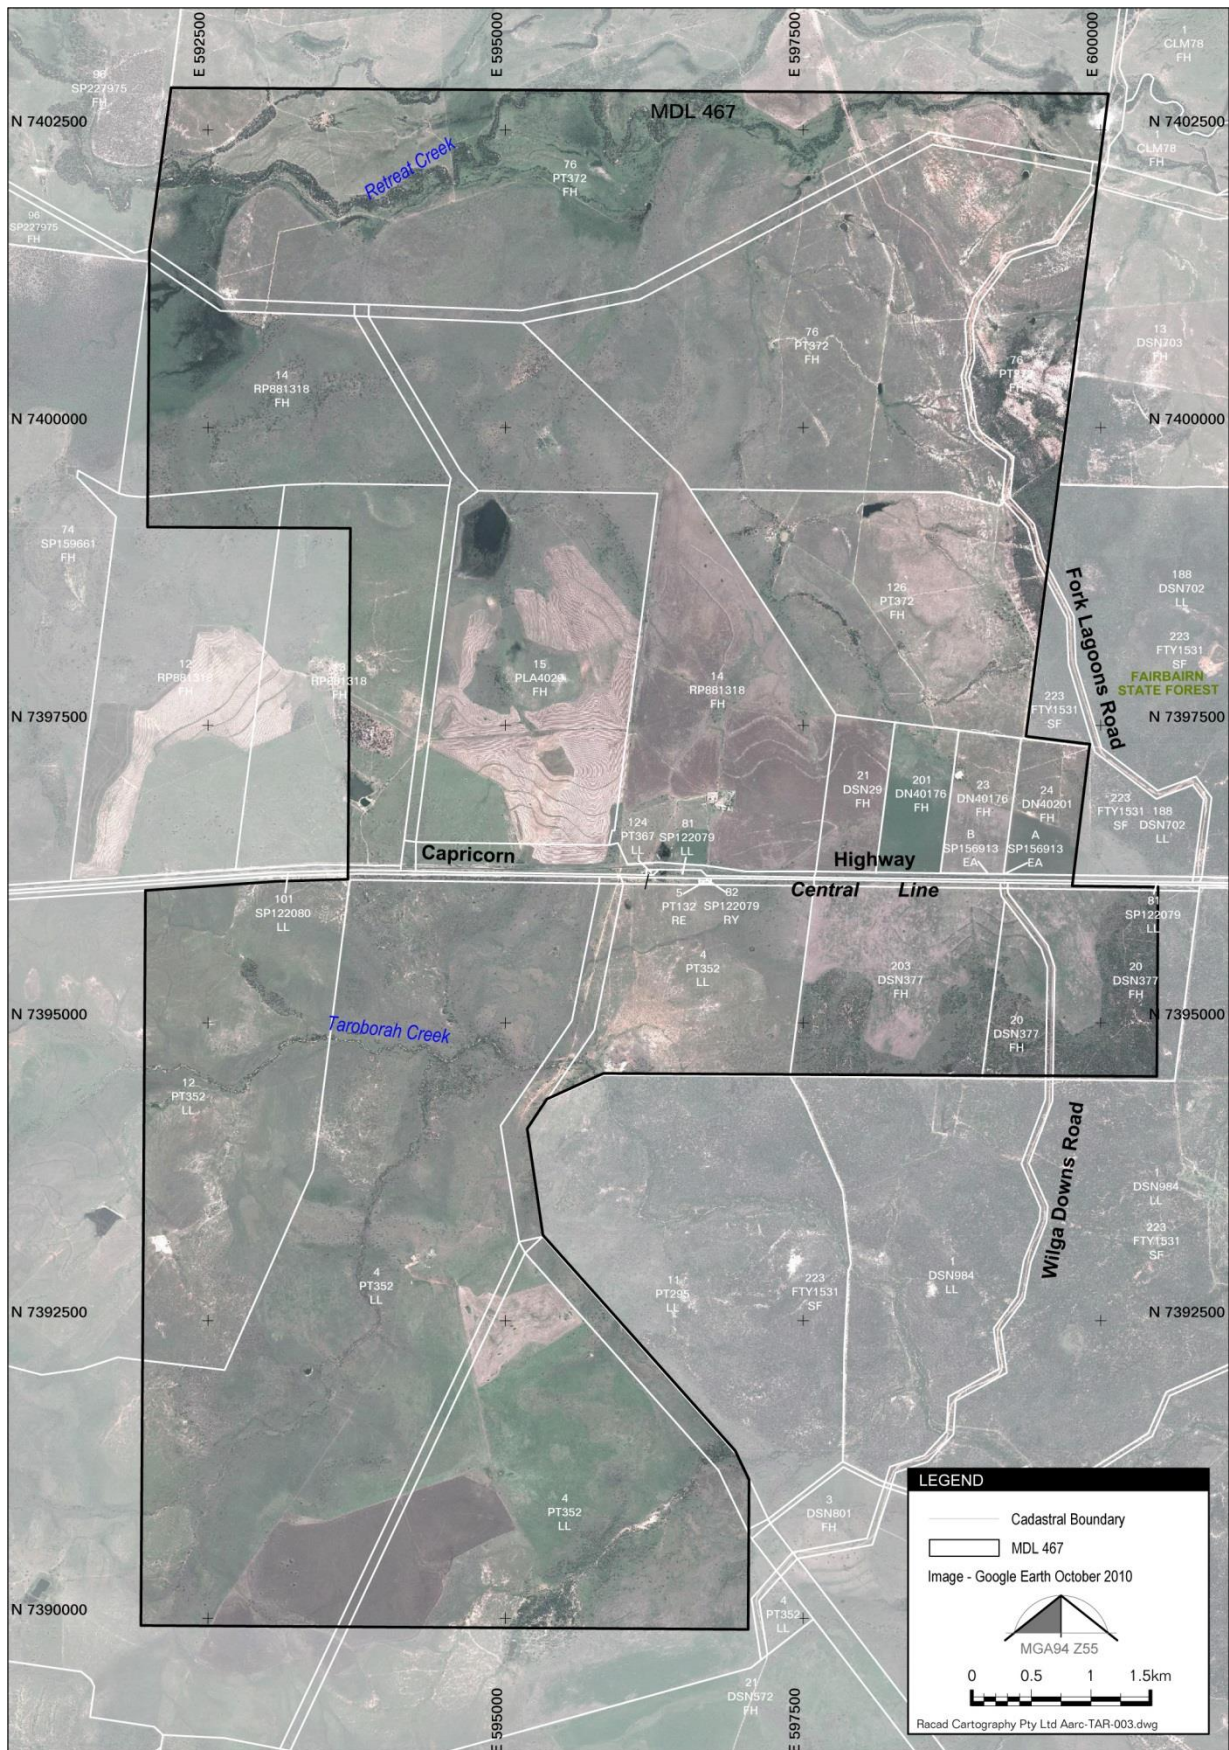
Figure 5 Landownership Cadastre for MDL467

A cadastral plan which indicates the various Lot on Plans which lie within and around MDL467 is presented in Figure 5.

A summary of the various landholders who own land within MDL467 is presented in Table 1. Note that not all Lots include homesteads. Refer to Figure 4 and Figure 5 for location details of the Taraborah homesteads and Lots.

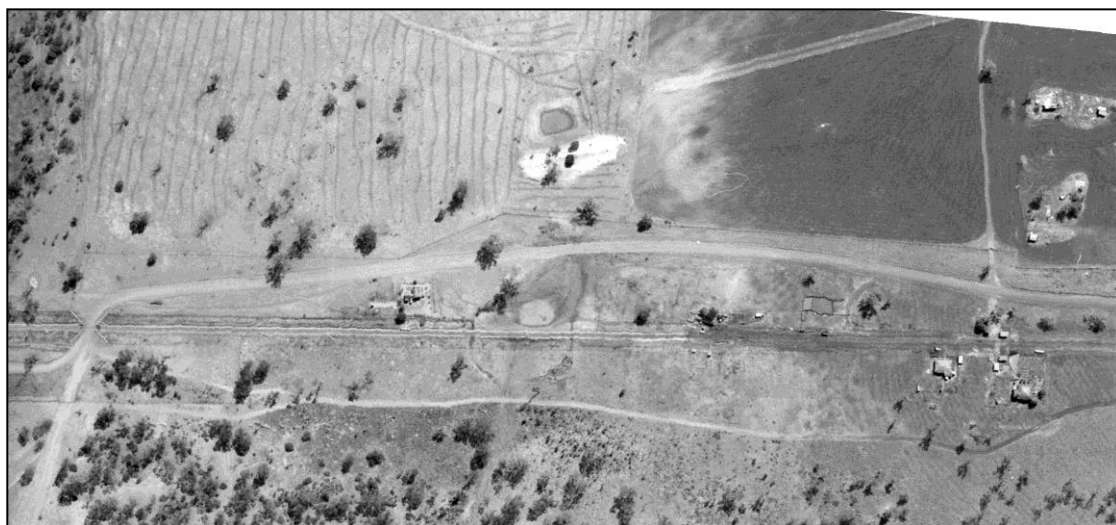
Figure 15 Taraborah Station - 1964

Agricultural activity has intensified surrounding the Taroborah Station and also surrounding the St Helens homestead which has been established on what is currently Lot 4 on PT352 (refer to Figure 15 and Figure 16 for details of these agricultural developments).

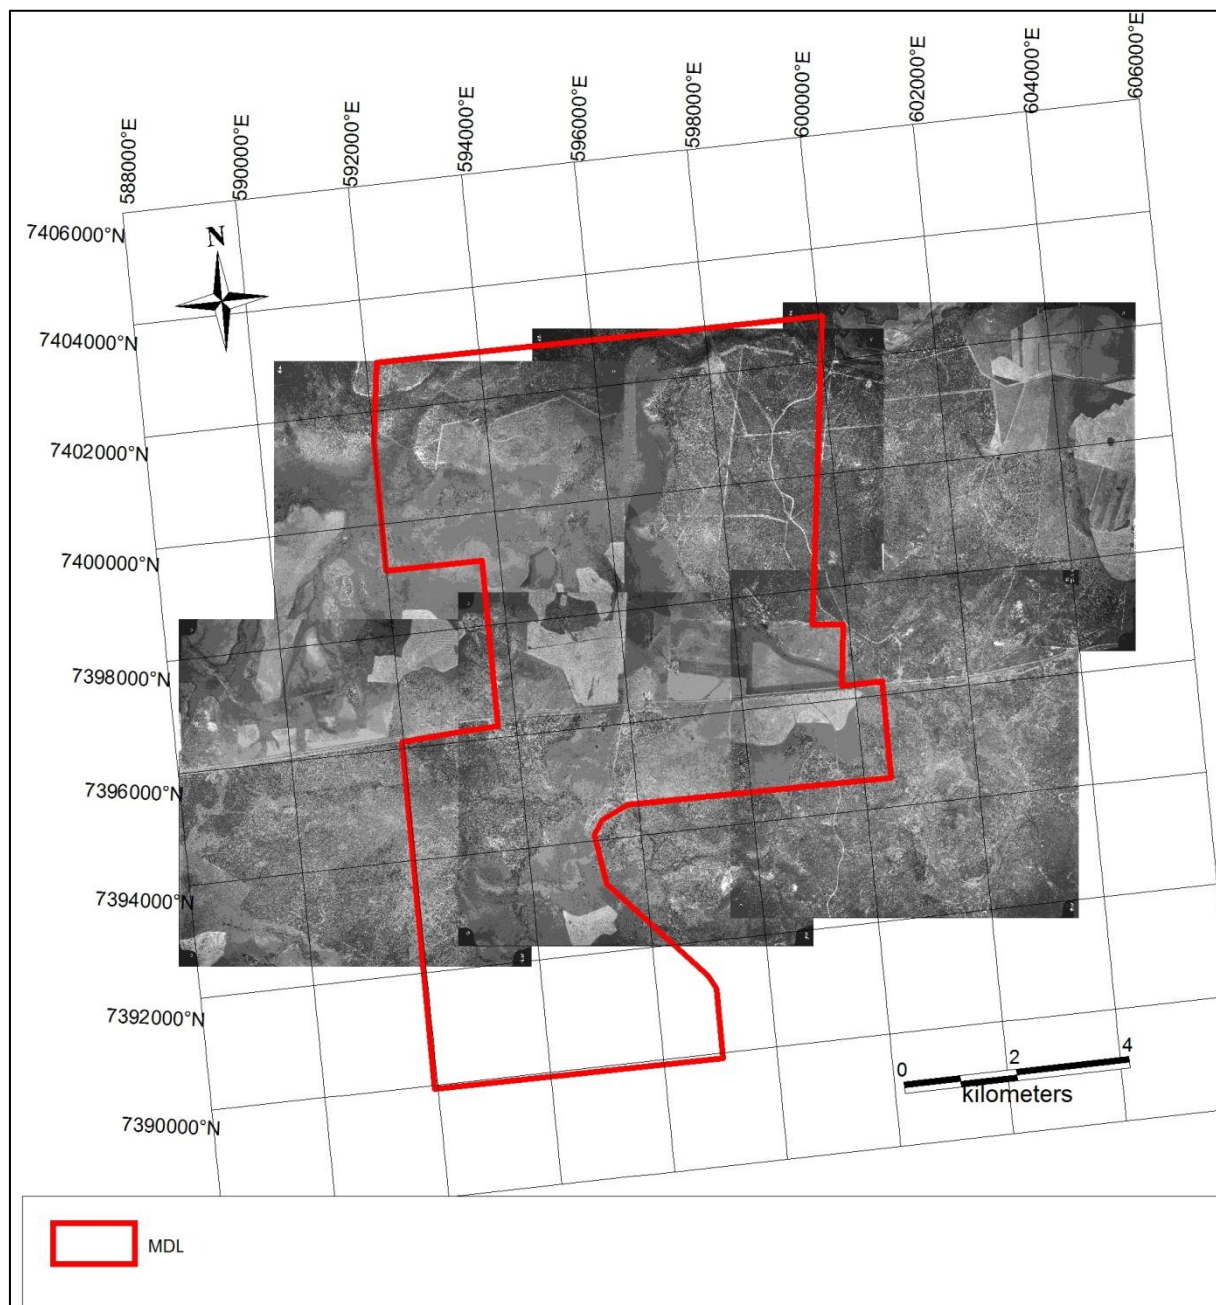
Figure 17 **Historical Aerial Photo (whole site) and MDL467 - 1983**

The aerial photography taken in 1983 and presented in Figure 17 demonstrates that further fragmentation has occurred within the Project area, which is particularly pronounced in the northern and western sections of the site. Broad-scale vegetation clearing has been undertaken and agricultural land established across the majority of the site north of the Capricorn highway.

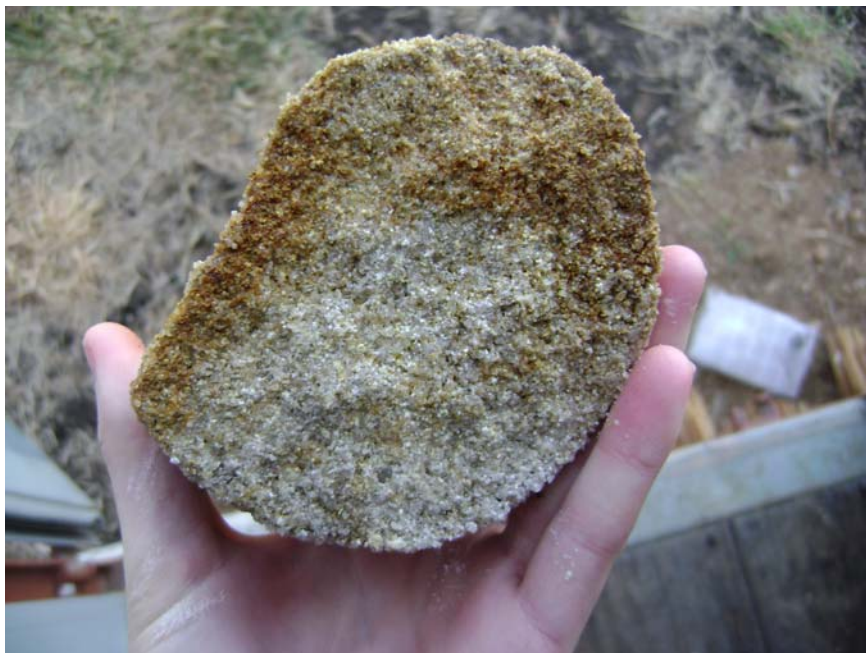
Figure 1 4" core hole TAR004 showing the Aldebaran Sandstone

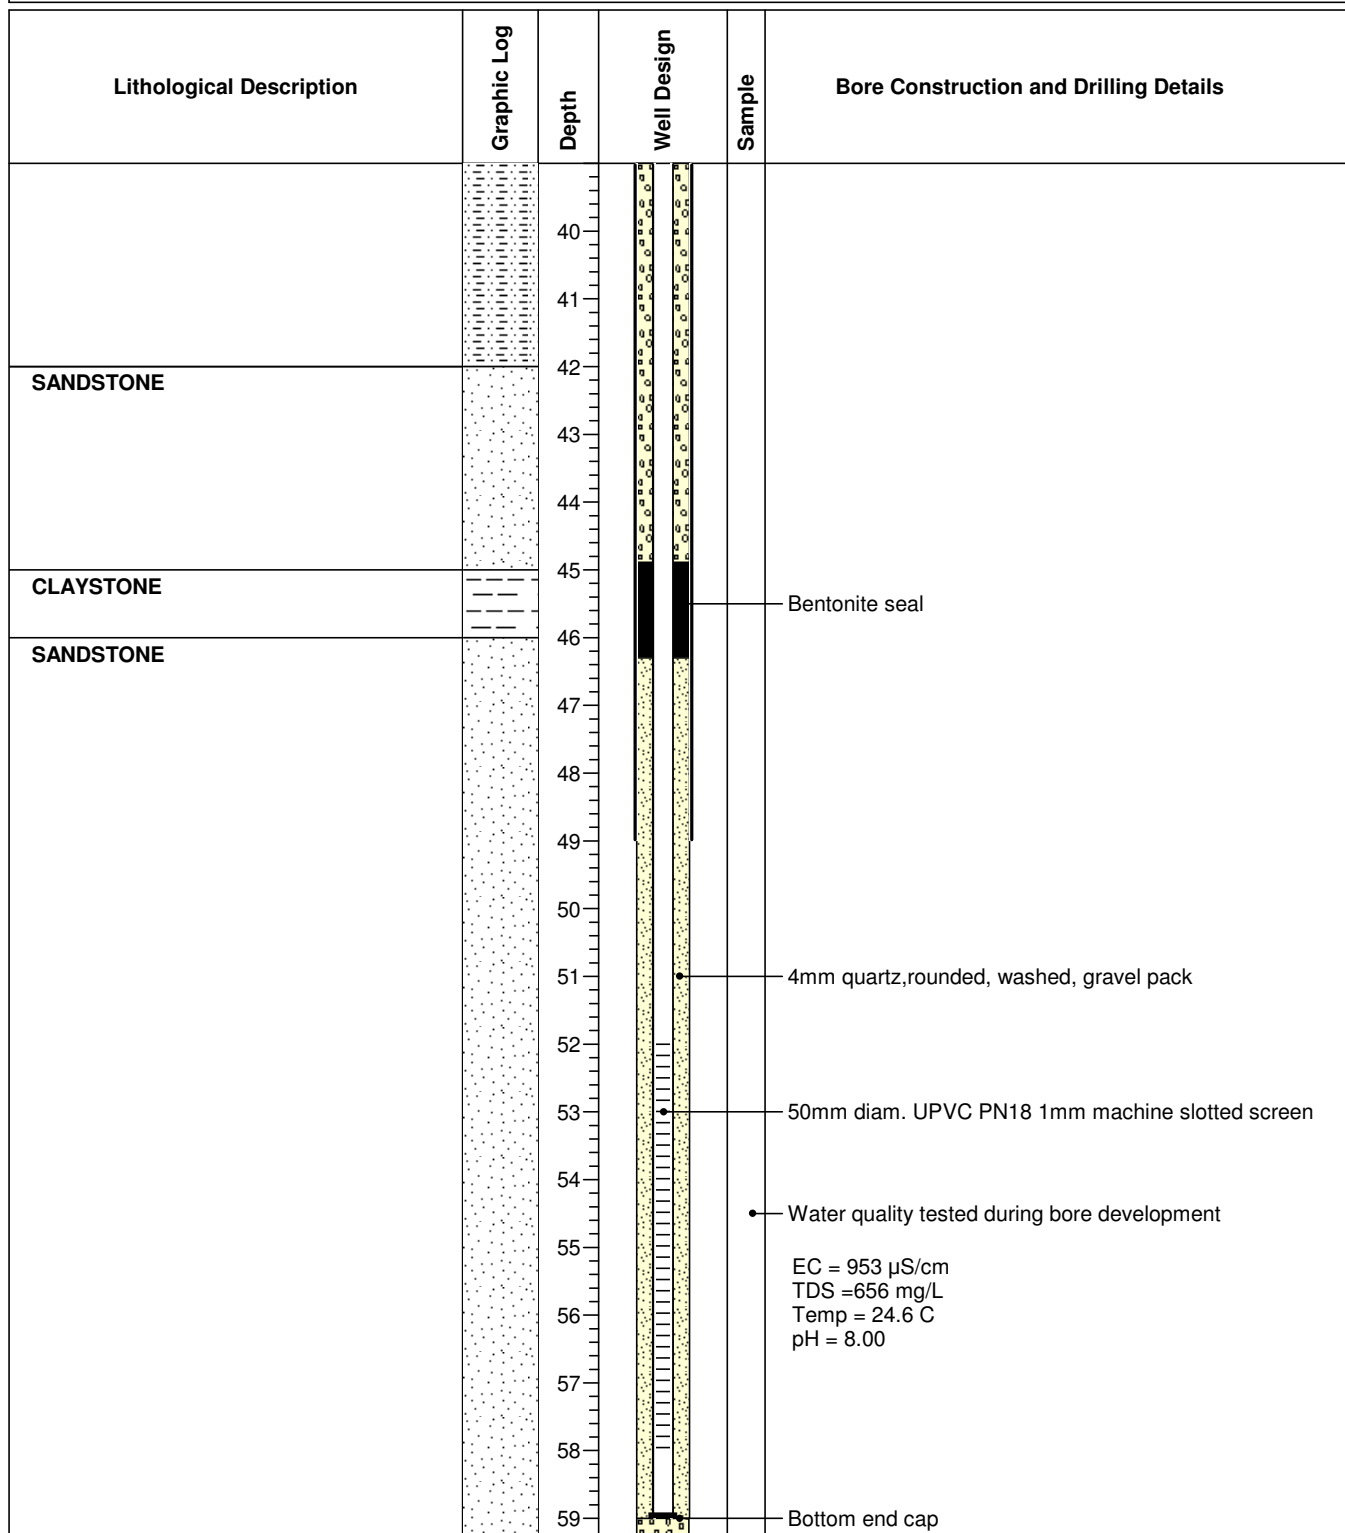
Borehole Log: TAR053

Drilling Company: Phoenix Drilling Services
Date Installed: 29/05/2008
Hole Type: Cored
Hole Diameter: 150mm
Depth of Casing: 5" 49m
Total Depth: 97m
